Certificate of Substantial Completion

21064 Pontotoc City Schools ESSER 2

Punch List First Phase Turnover - August 3, 2022

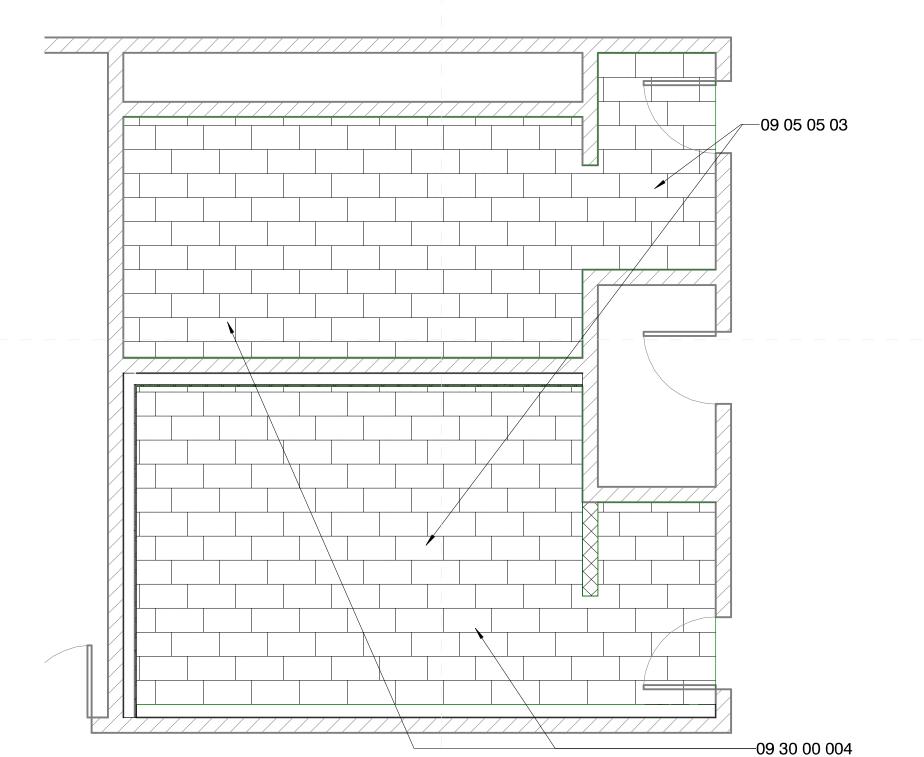
PCD HS Acad. Toilets -Floor Pattern

WOTK
09 05 05 02	Patch damaged substrate for smooth new tile installation
09 05 05 03	Install leveling compound as needed for smooth appearance of new tile, typical on new floor tile
09 30 00 004	New 12x24 Tile as shown
09 30 00 005	Install new wall tile flush and straight with accent top piece, floor to partial wall/window sill height; typical at bathroom interior unless noted otherwise
09 30 00 007	Install new wall tile flush and straight, floor to ceiling at this plumbing wall only
09 30 00 008	Install accent tile at this wall
10 21 13.19 001	Install new toilet partitions (typical)
10 28 13 001	Install wall hung mirror here; center over fixture unless noted otherwise

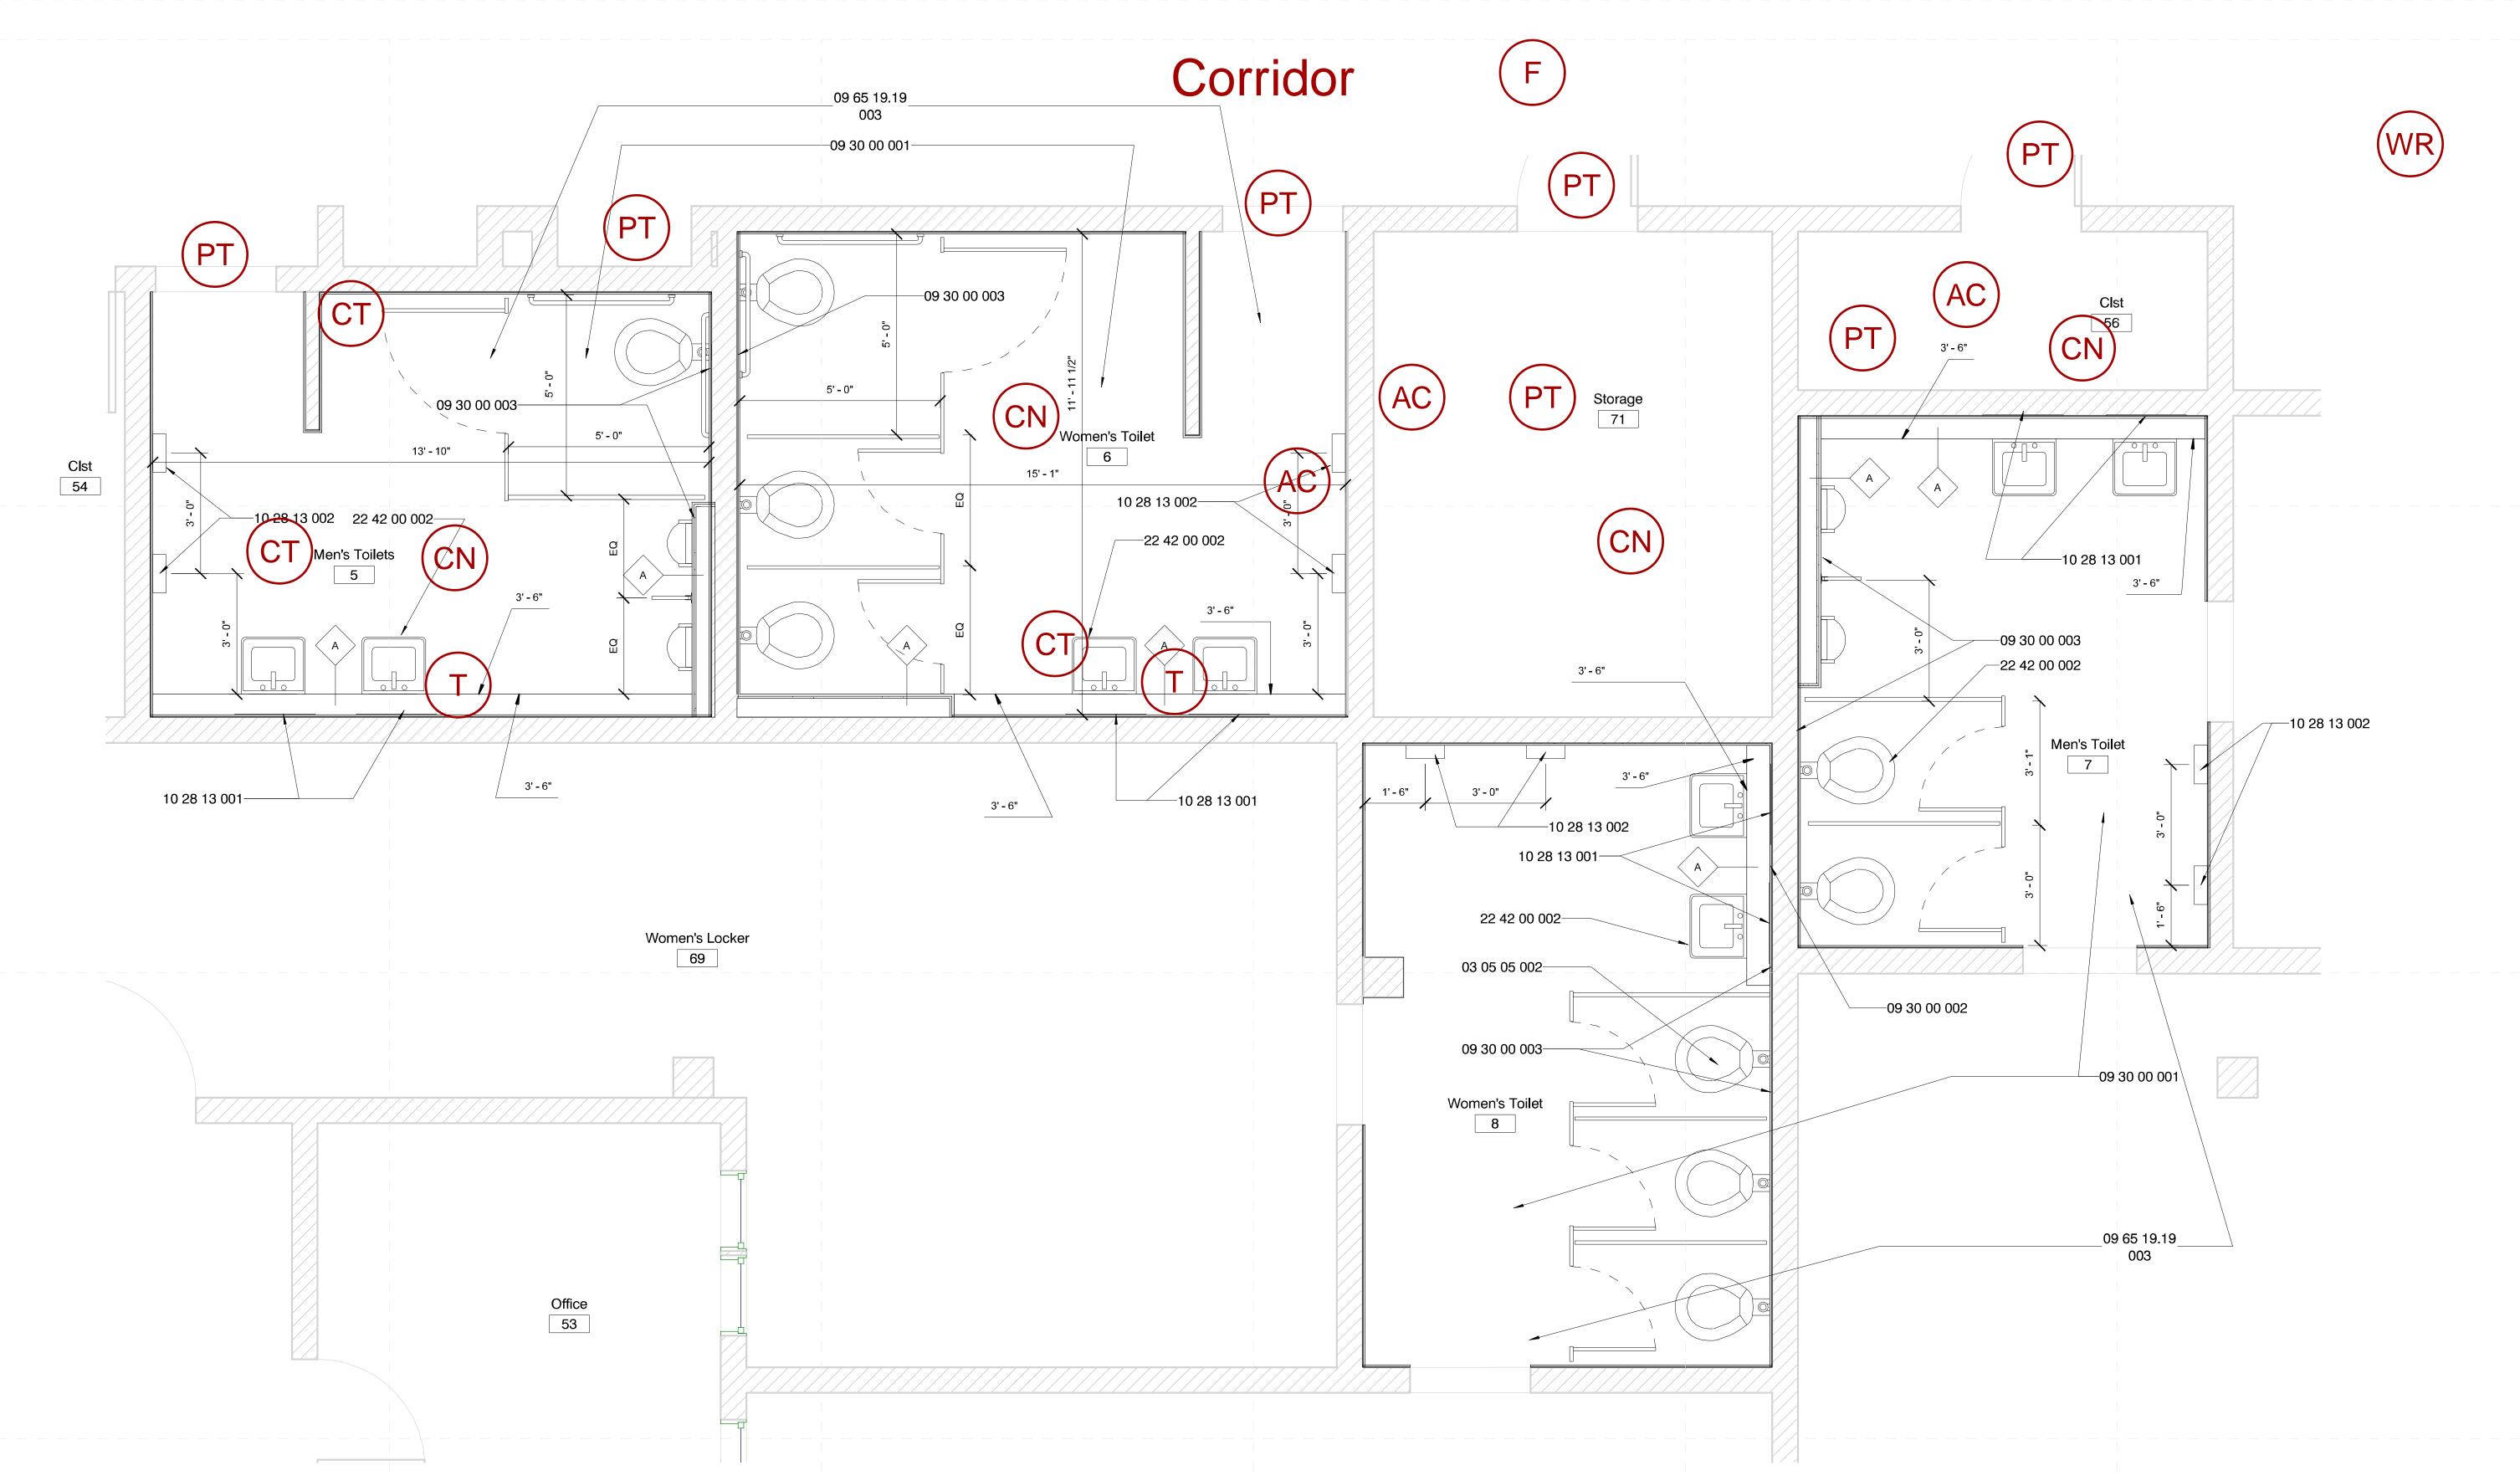
PCS Junior High 1st LVL - Toilets

- 1. Prep floors; secure loose substrates
- 2. Install new LVT at all floors unless noted otherwise 3. Install new rubber base at all new floors except for tile

- A. Floor Tile pattern shall be staggered in thirds and run lengthwise in toilet rooms at floor, continuing in same pattern at designated accent wall
- B. Unless otherwise noted, 5/8" sheetrock shall be installed above partial height walls to a MIN of 4" above ceiling grid. Tile walls full height elsewhere throughout toilet
- C. Coordinate wall tile pattern with architect.
